# **Sand and Gravel Mining**

## **Floodplain Use Permit Guidelines**

**PINAL COUNTY  
May 2006**

**JE FULLER**  
HYDROLOGY & GEOMORPHOLOGY, INC.

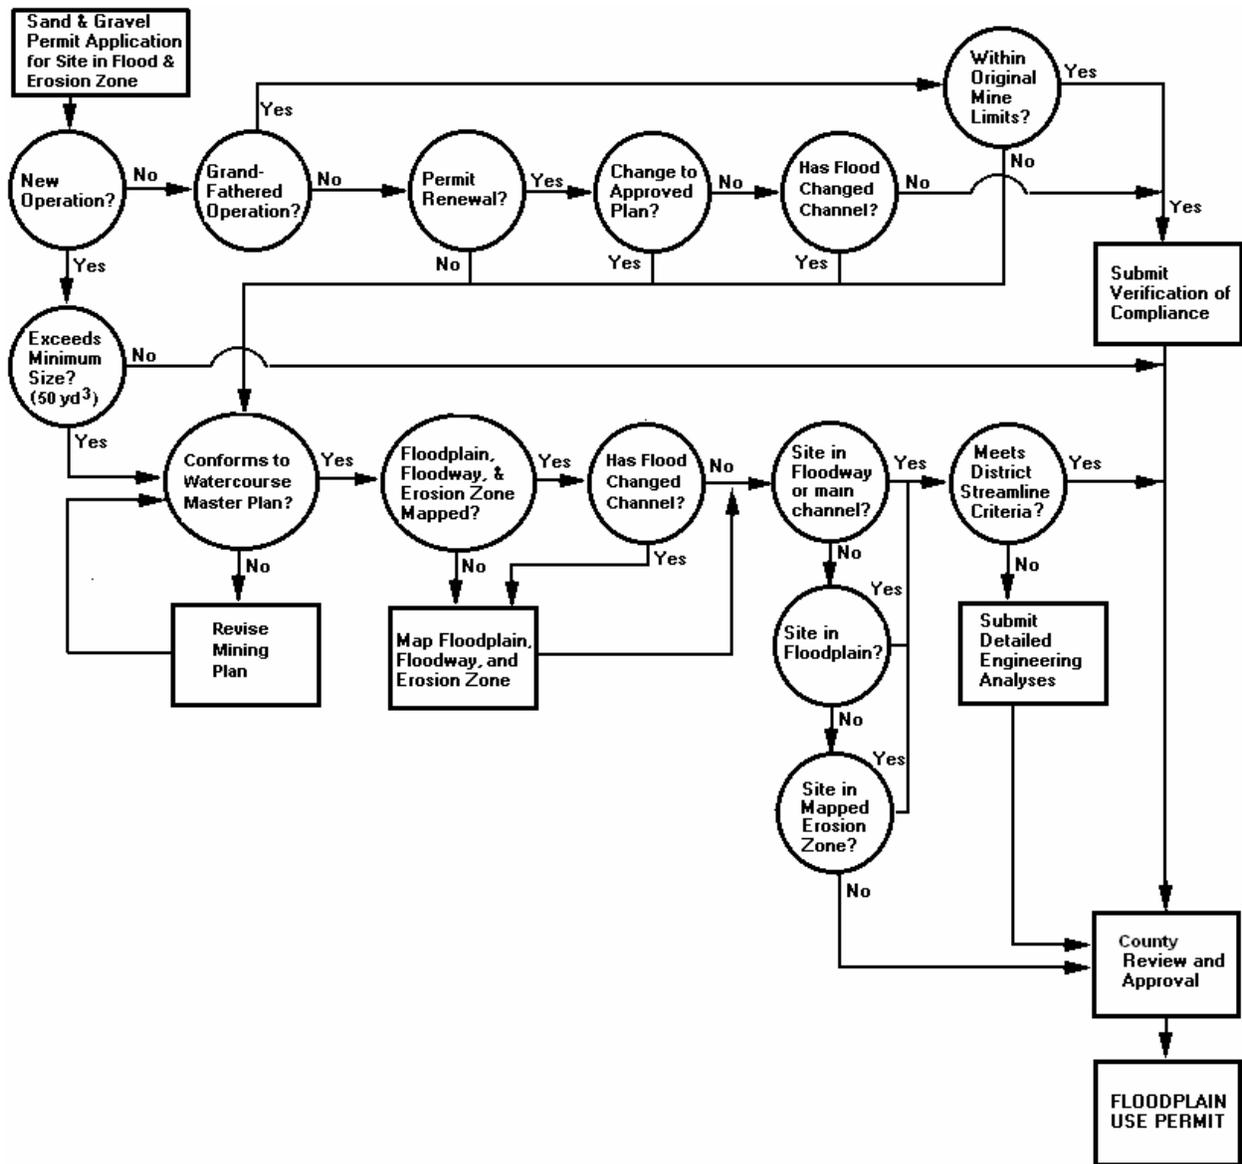
Figure 1-1. Flow chart showing the floodplain use permit application process for sand and gravel mines.

As shown in Figure 1-1, the application approval process can be streamlined by excavating outside the flood and erosion hazard zone, by limiting the size of the excavation to less than 50 yd<sup>3</sup> or by meeting the District’s “streamlined criteria” for excavations in the FLOOD HAZARD ZONE, as described in Section 4, or by documenting compliance with the conditions of a previously approved floodplain use permit.

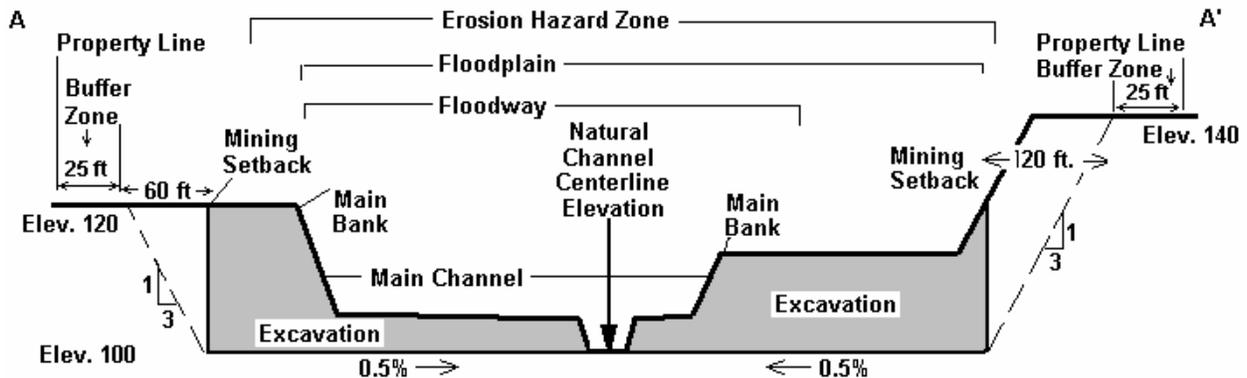
Figure 5-1. Main channel and floodway excavation geometry for streamlined floodplain use permits. Plan view is shown in Figure 5-2. This pit is 20 feet deep (Elev. 120 – Elev. 100). The shaded area marked “Excavation” is the area that can be mined under the streamlined permit process. Material may not be excavated from areas outside the shaded zone unless an engineering analysis is submitted.

- 3.) If aggregate mines are located within the regulatory floodway or erosion hazard zone and no STRUCTURAL FLOOD CONTROL MEASURES are provided, the maximum excavation depth should be no greater than the natural CHANNEL INVERT elevation shown on the EFFECTIVE FLOODPLAIN DELINEATION study (Figure 5-1).

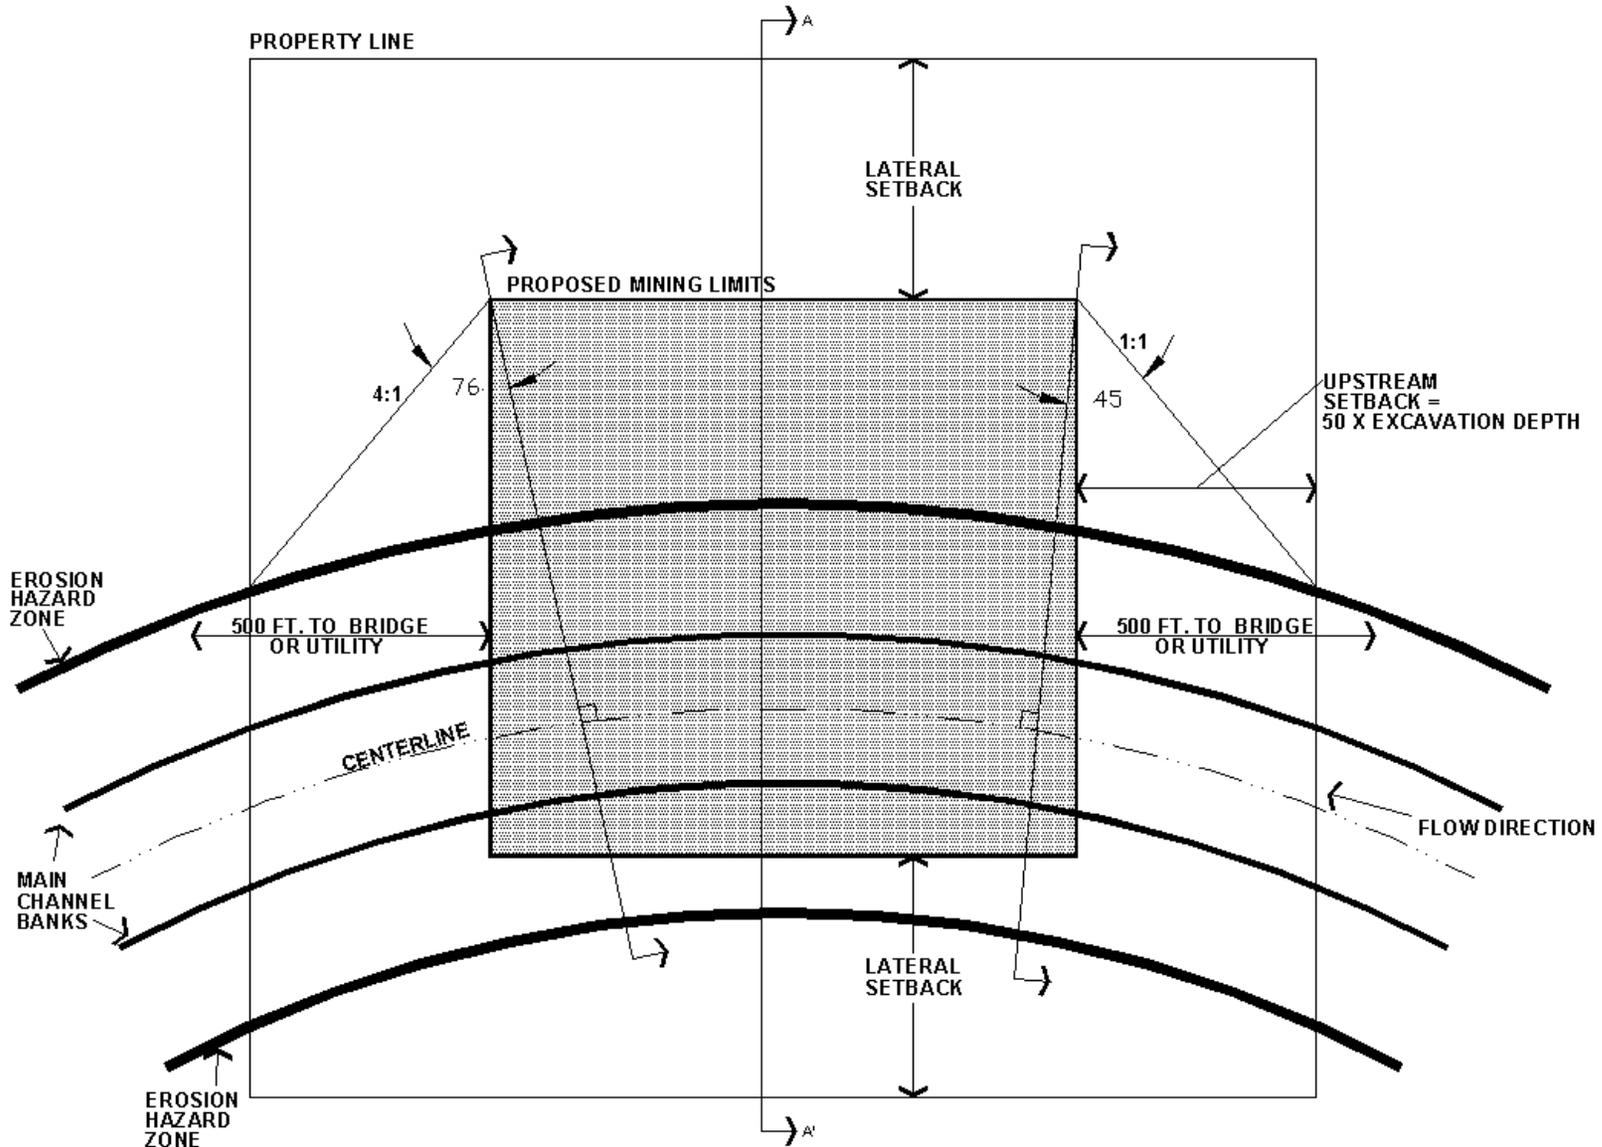
Figure 5-2. Upstream and downstream setbacks from property lines for excavations that extend outside the erosion hazard zone.

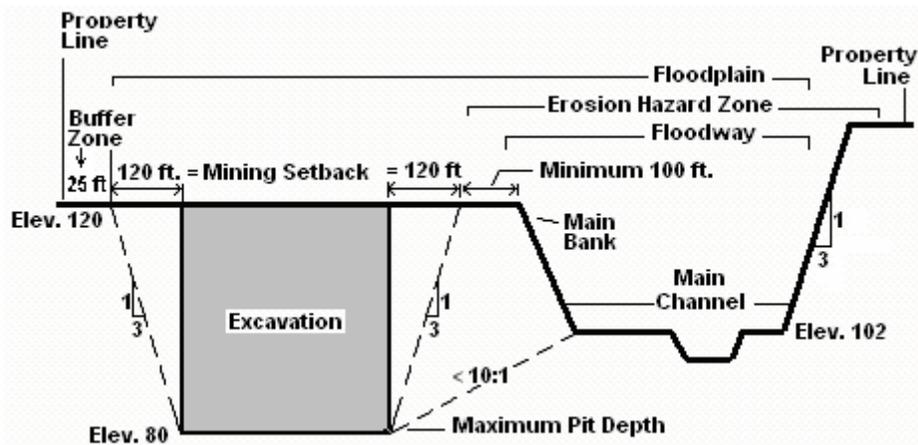
Figure 5-3. Floodplain excavation pit geometry for streamlined floodplain use permit. Pit is 40 ft deep.

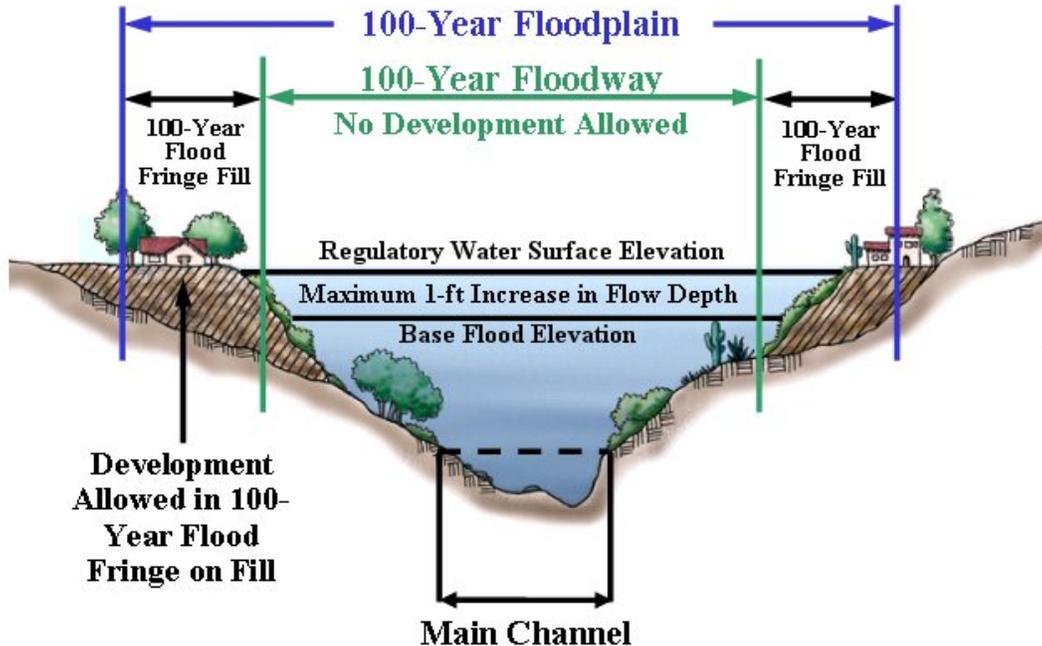
Figure 6-1. Illustration of Floodway, Floodway Fringe, Base Flood Elevation, and Regulatory Water Surface Elevation for a typical riverine floodplain.

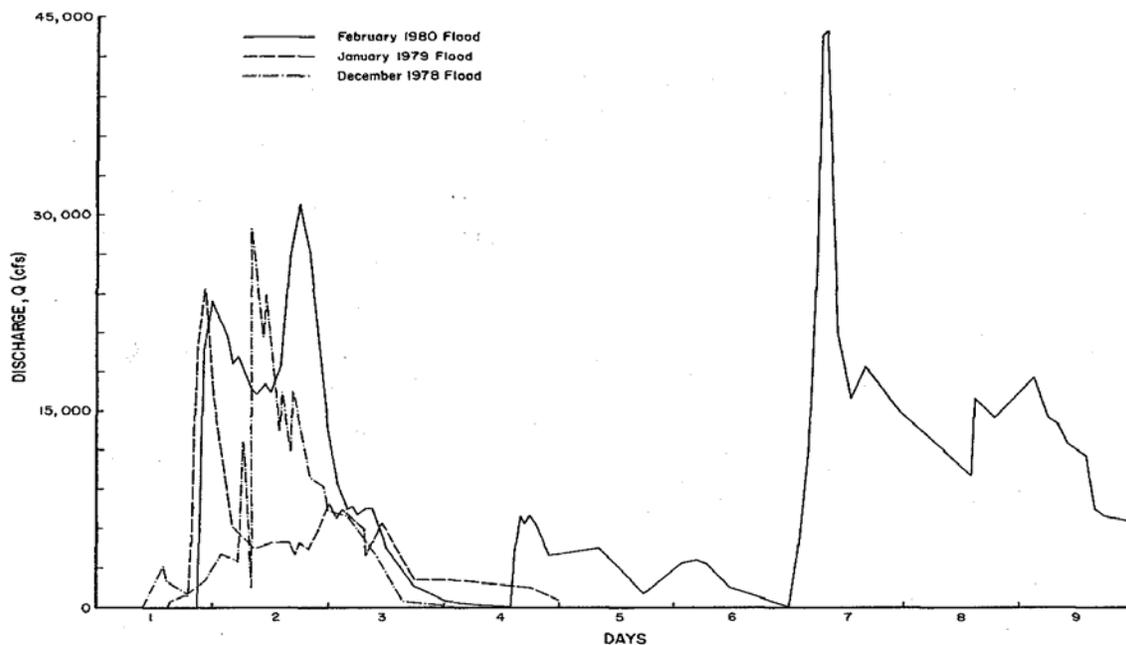
Figure 5. Estimated flood hydrographs for the 1978, 1979, and 1980 floods on the Agua Fria River at the Avondale gauge (Source: USACE, 1981). Note the rapid rise of the hydrograph on Feb. 20<sup>th</sup> 1980 where discharge jumped from 18,000 to 44,000 and back to 18,000 in less than 8 hours.

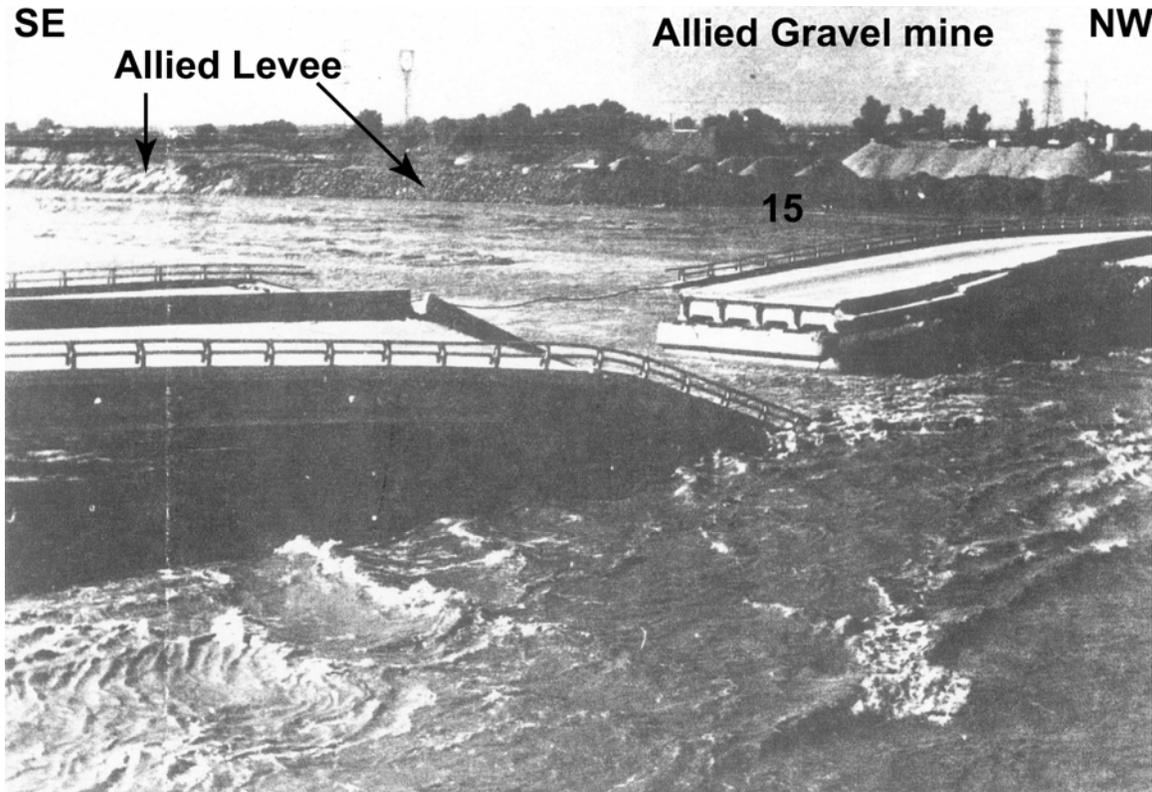
*Figure 6. Photograph looking downstream at the Indian School Bridge collapse during the 1980 flood.*

At 8:15 a.m. on February 20, Maricopa County highway workers noticed a sag in the Indian School Road Bridge. Within 10 minutes, a section near the eastern end of the bridge had dropped by 2.5 feet. About an hour later the bridge span between piers 15 and 16 collapsed into the river, leaving only two intact crossings over the Agua Fria River and tying up traffic for weeks (Arizona Republic, 1980). Photographs of the collapsed bridge are shown in Figures 6 to 8.

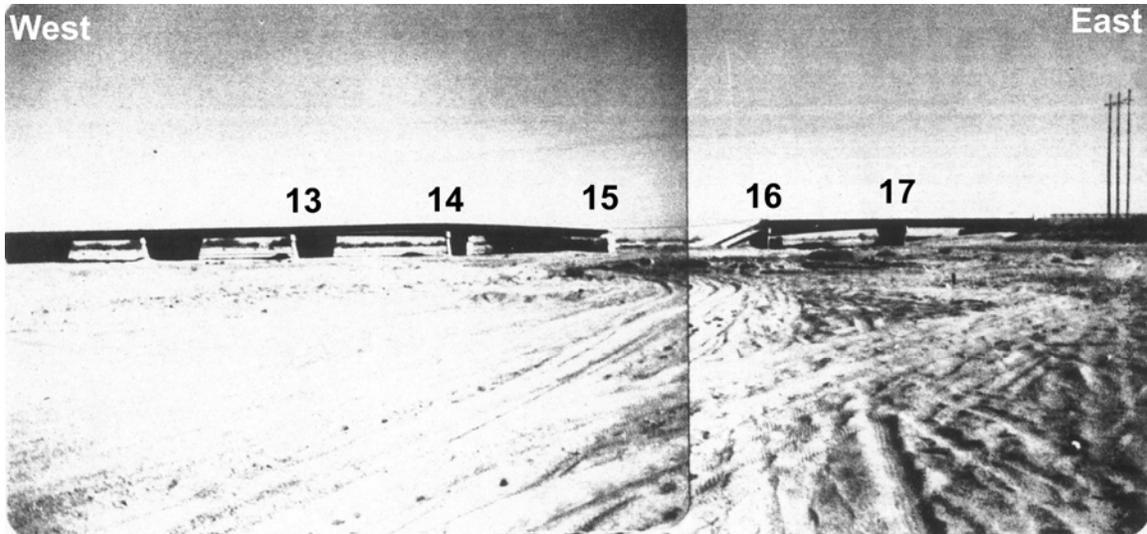
Figure 7. Photograph looking upstream at failed bridge after February 26<sup>th</sup>. Pier numbering indicated.

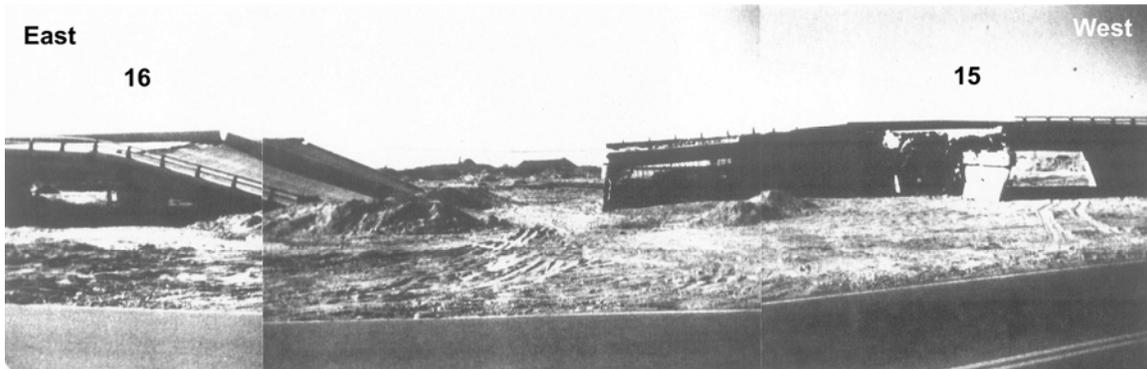
Figure 8. Photograph looking downstream (south) at failed bridge after February 26<sup>th</sup>.

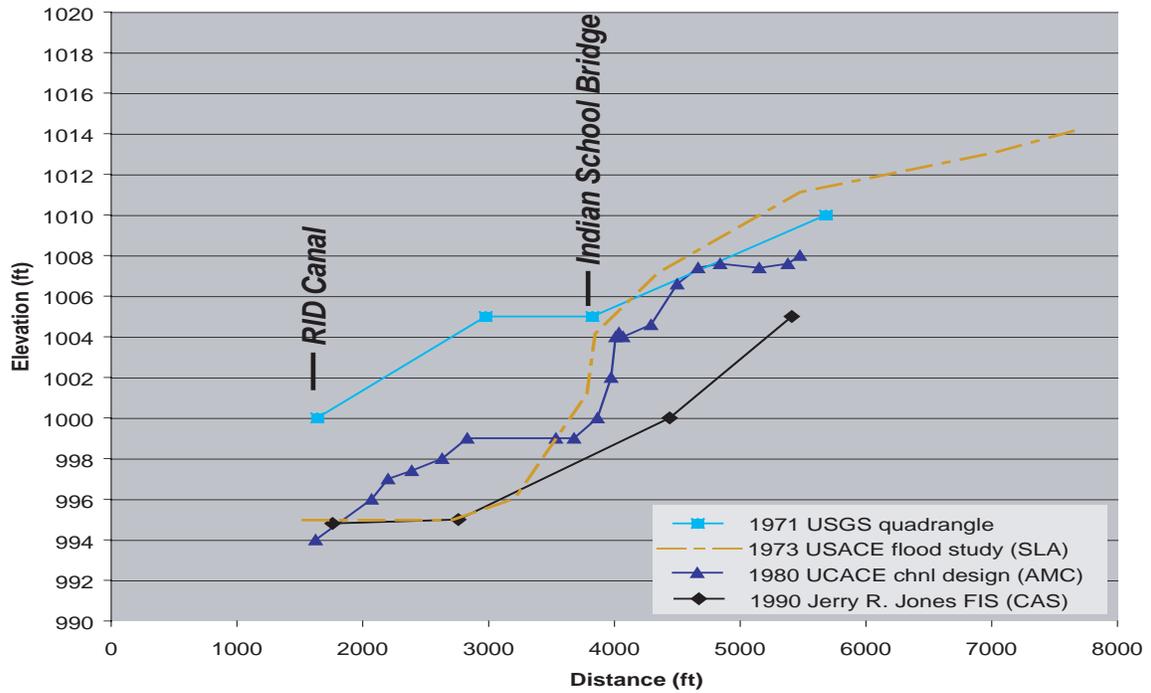
Figure 9. Thalweg profiles for the Agua Fria channel bed.

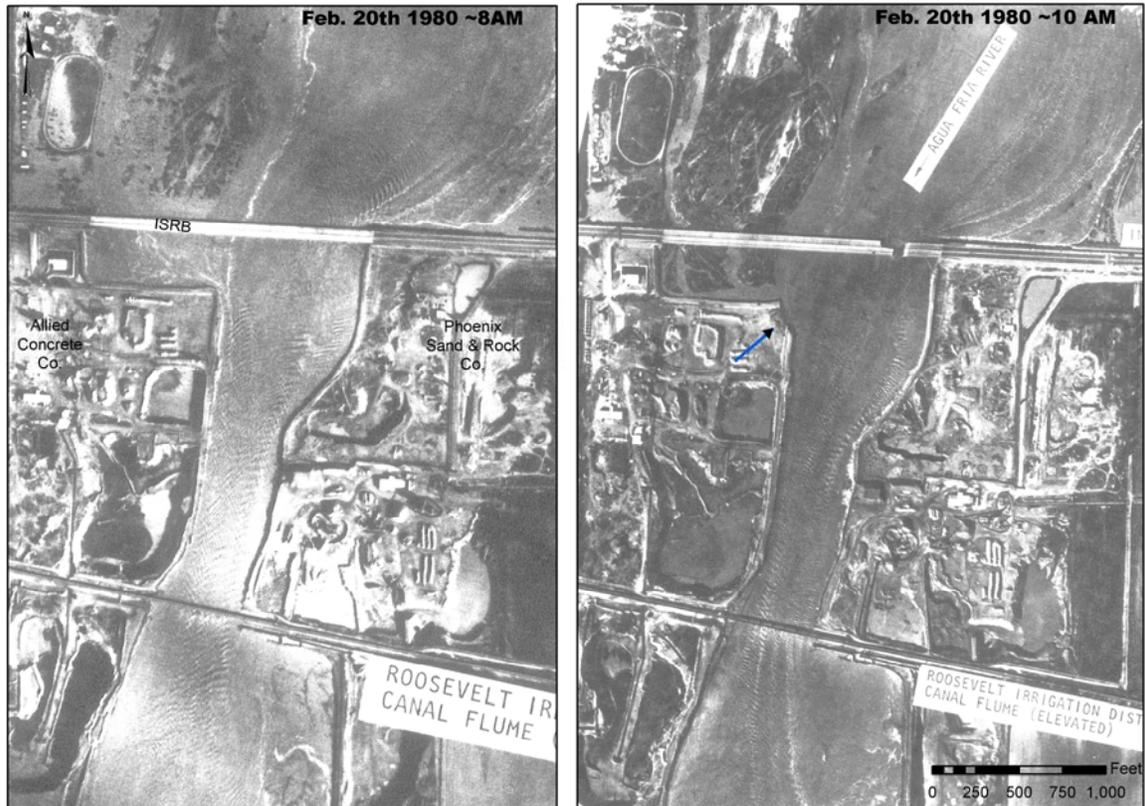
Figure 10. February 20<sup>th</sup>, 1980 aerial photographs taken before and after the Indian School Road Bridge collapse. Note the flow constriction at the ISRB, high angle of flow to the eastern piers, and erosion of the tip of the western (Allied) levee (blue arrow).

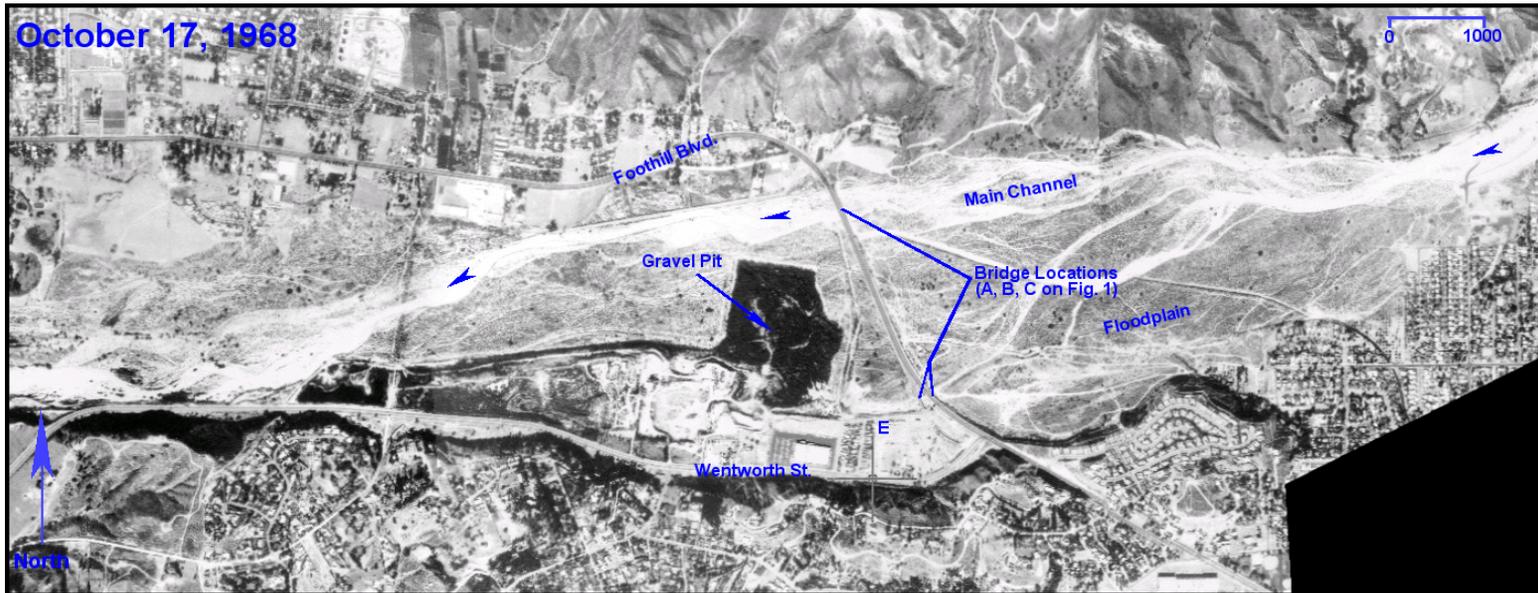
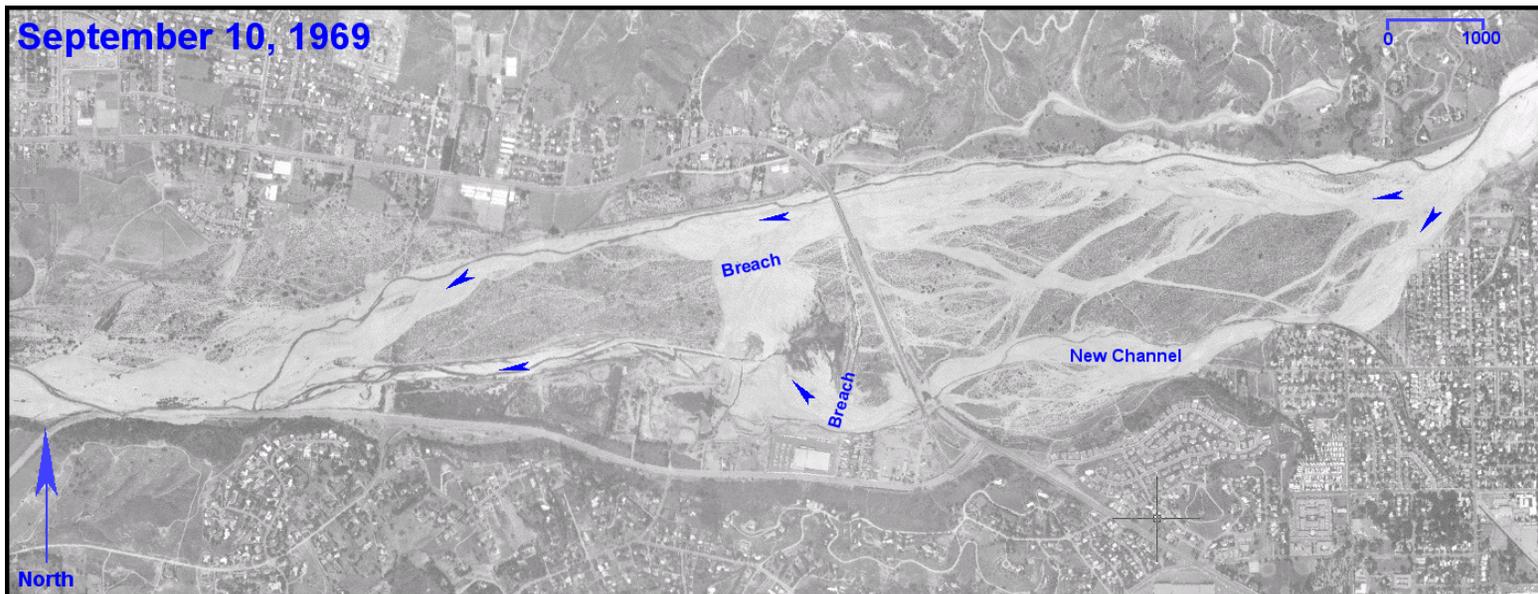
Figure 4. Pre- and post-flood view of entire reach. Note: 1969 photography was taken after two of the original three bridges were replaced.

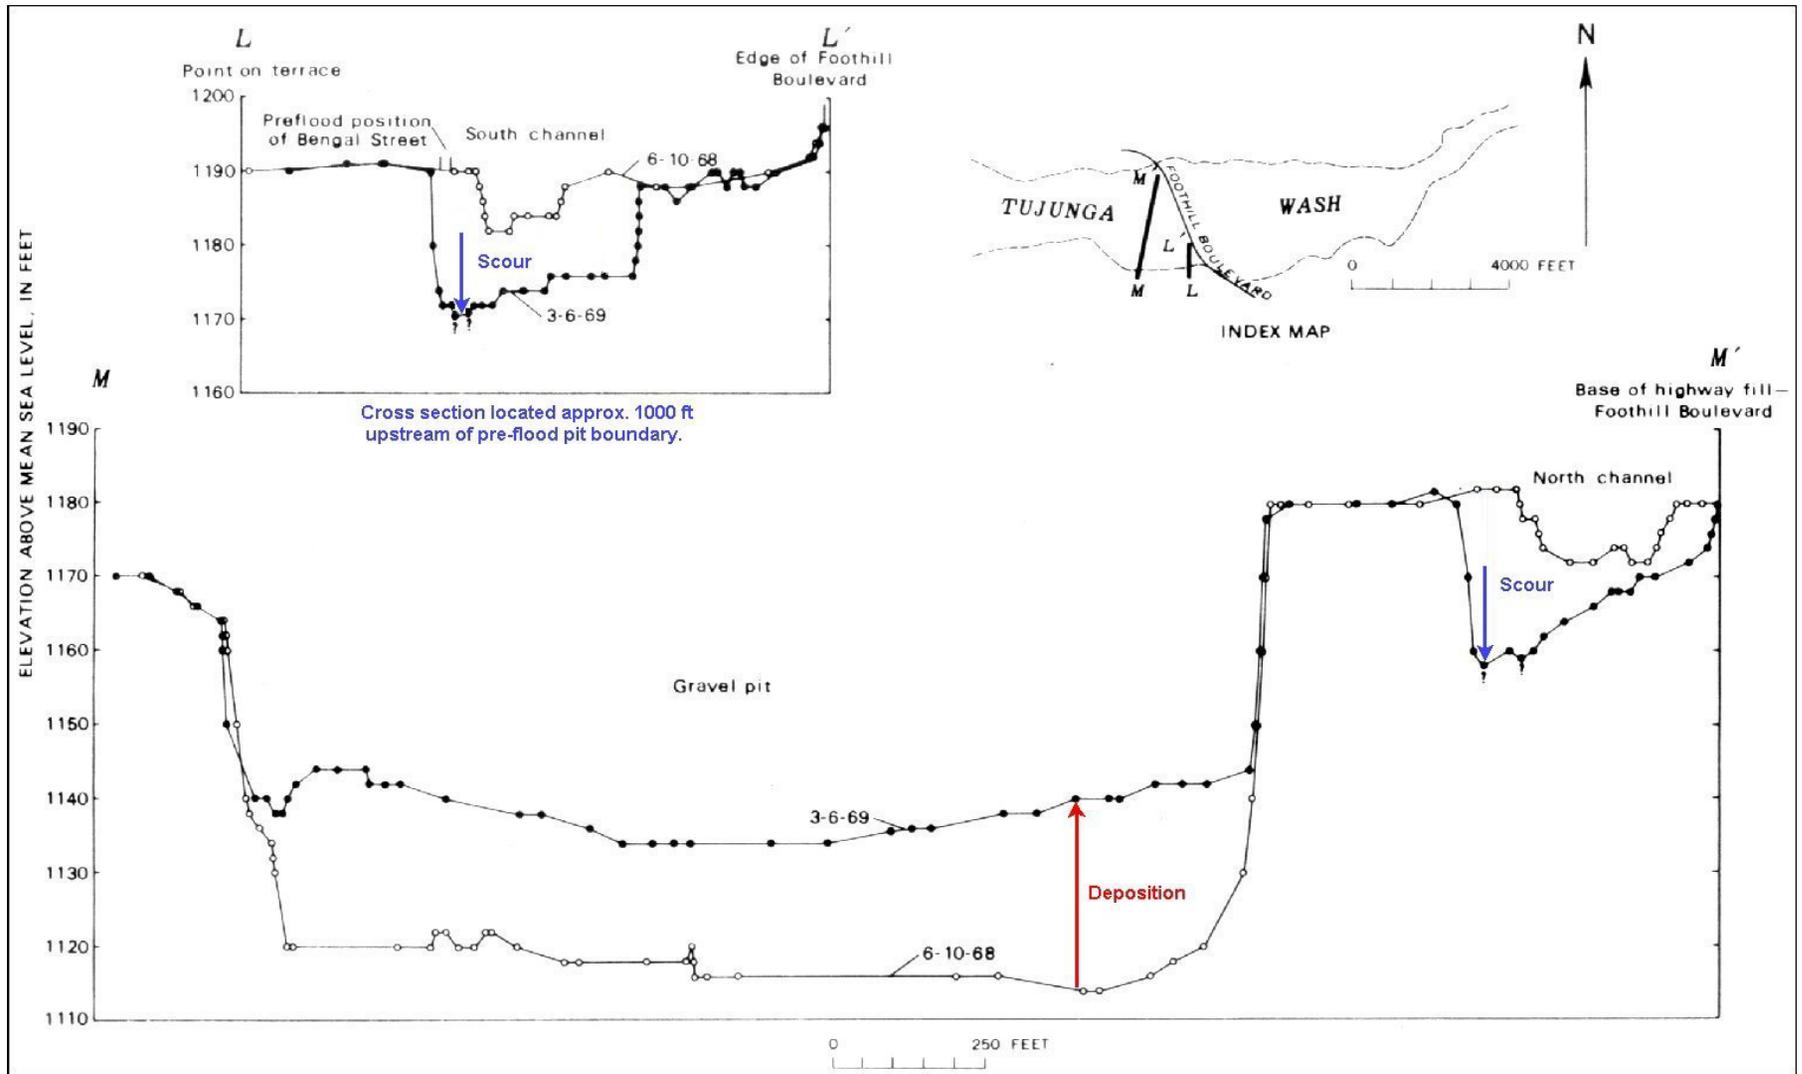
Figure 5. Figure showing example of bed elevation change at two locations on Tujunga Creek. Cross section M-M' is across gravel pit and cross section L-L' is located just upstream of the gravel pit (Original figure taken from Scott, 1973).

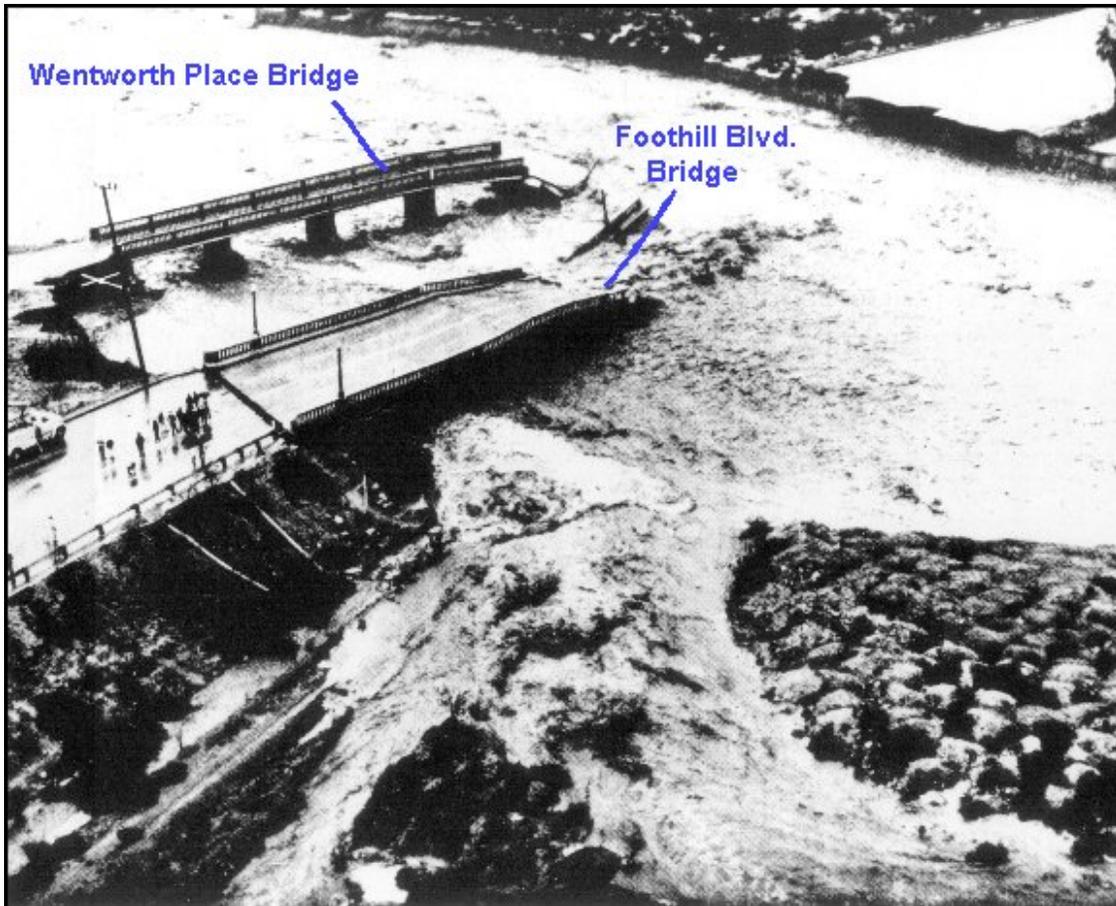
*Figure 6. Picture by Harold Morby looking downstream (NW) at Foothill Blvd. and Wentworth Place bridge failures (from Scott, 1973).*

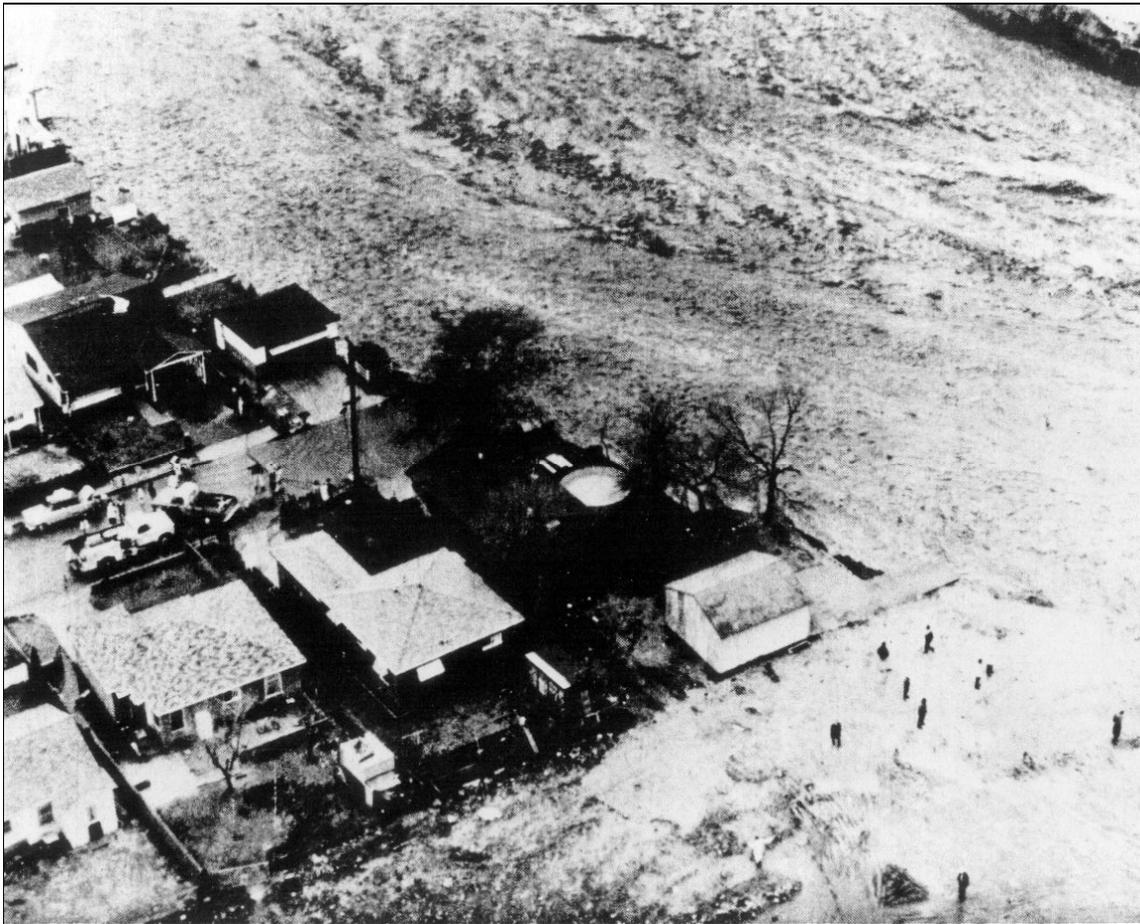
*Figure 7. Photograph by Harold Morby looking downstream (NW) at lateral erosion of left bank near Bengal Street. From Scott, 1973. See Figure 8 for photo location.*

(1973) stated that lateral erosion in excess of the natural rate of lateral erosion occurred near the sand and gravel pit due to two major factors. First, the channel widened to compensate for the significant increase in discharge capacity caused both by the large flood itself and by erosion and degradation that increased the percentage of flow conveyed in the channel instead of the floodplain. Second, bank stability decreased due to headcutting initiated by breaching of the gravel pit. Lowering of the bed elevation by headcutting increased the bank height, removed basal support at the bank toe, exposed unvegetated bank material to hydraulic forces, and increased the channel velocity. Pre- and post-flood aerial photography shown in Figures 4 and 8 can be compared to indicate the magnitude and extent of lateral channel changes.

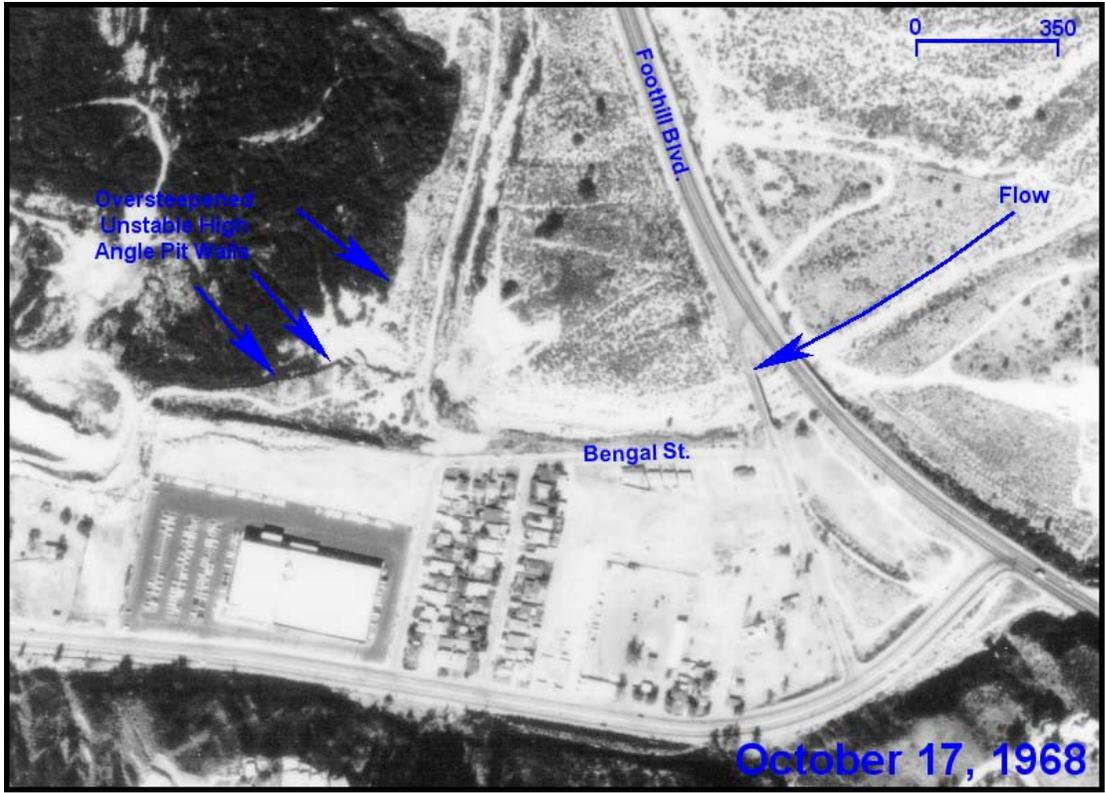
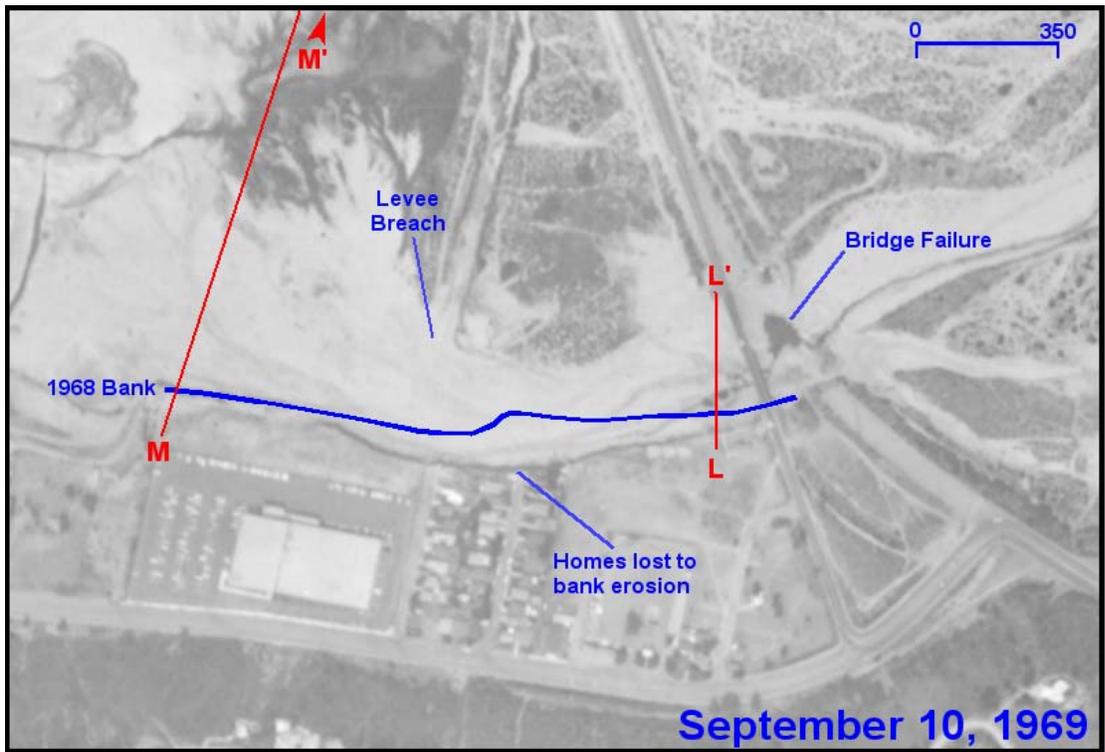
Figure 8. Lateral bank erosion that destroyed 7 homes and Bengal St. See Figure 5 for topography at cross sections M-M' and L-L'. Note: The bridge in the 1969 photograph was built after the flood.

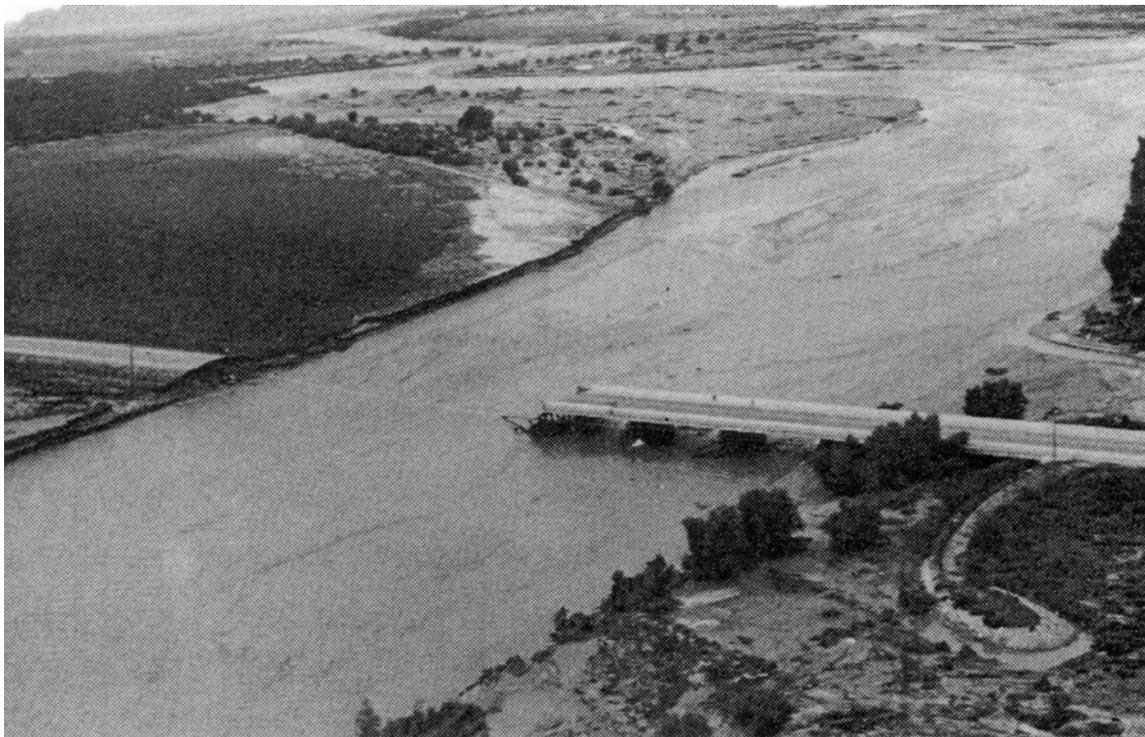
**Figure 2. Aerial photograph of the Ina Road Bridge, Santa Cruz River, AZ, looking northwest after the 1983 flood (PCDOT, 1984). The gap in the roadway was due to failure of the west abutment by lateral erosion.**

On the morning of October 3<sup>rd</sup>, 17 of the 18 bridges crossing the Santa Cruz River in Pima County were inoperable or unsafe for occupation (Saarinen et al., 1984). The Ina Road Bridge suffered extensive damage including failure of the west abutment as a result of erosion to the west bank, breaking off of the south wing wall and support pile, settling of the southwest corner of the west abutment, and loss of east and west approaches (Figure 2 to 4).

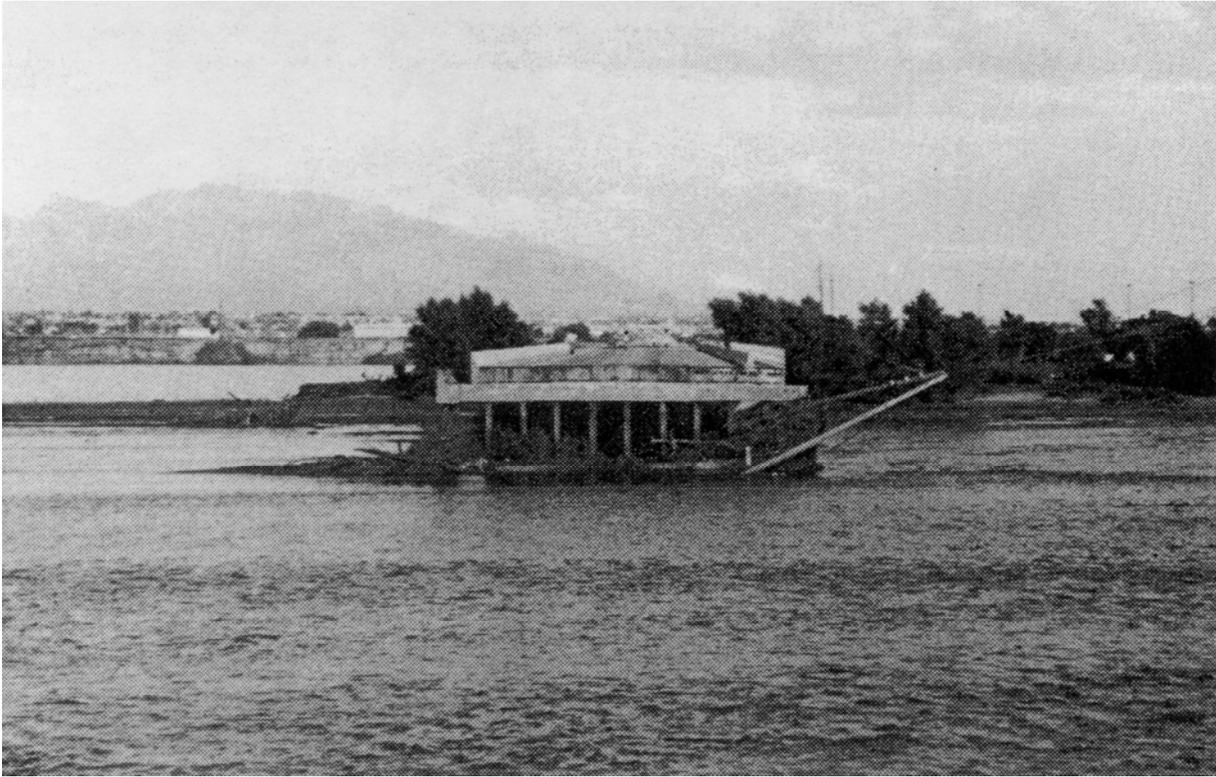
*Figure 4. Photograph of the Ina Road Bridge, Santa Cruz River, AZ, looking east from the west bank of the river (PCDOT, 1984). Note the breached and flooded Columbia Materials pit in the upper left of the photograph.*

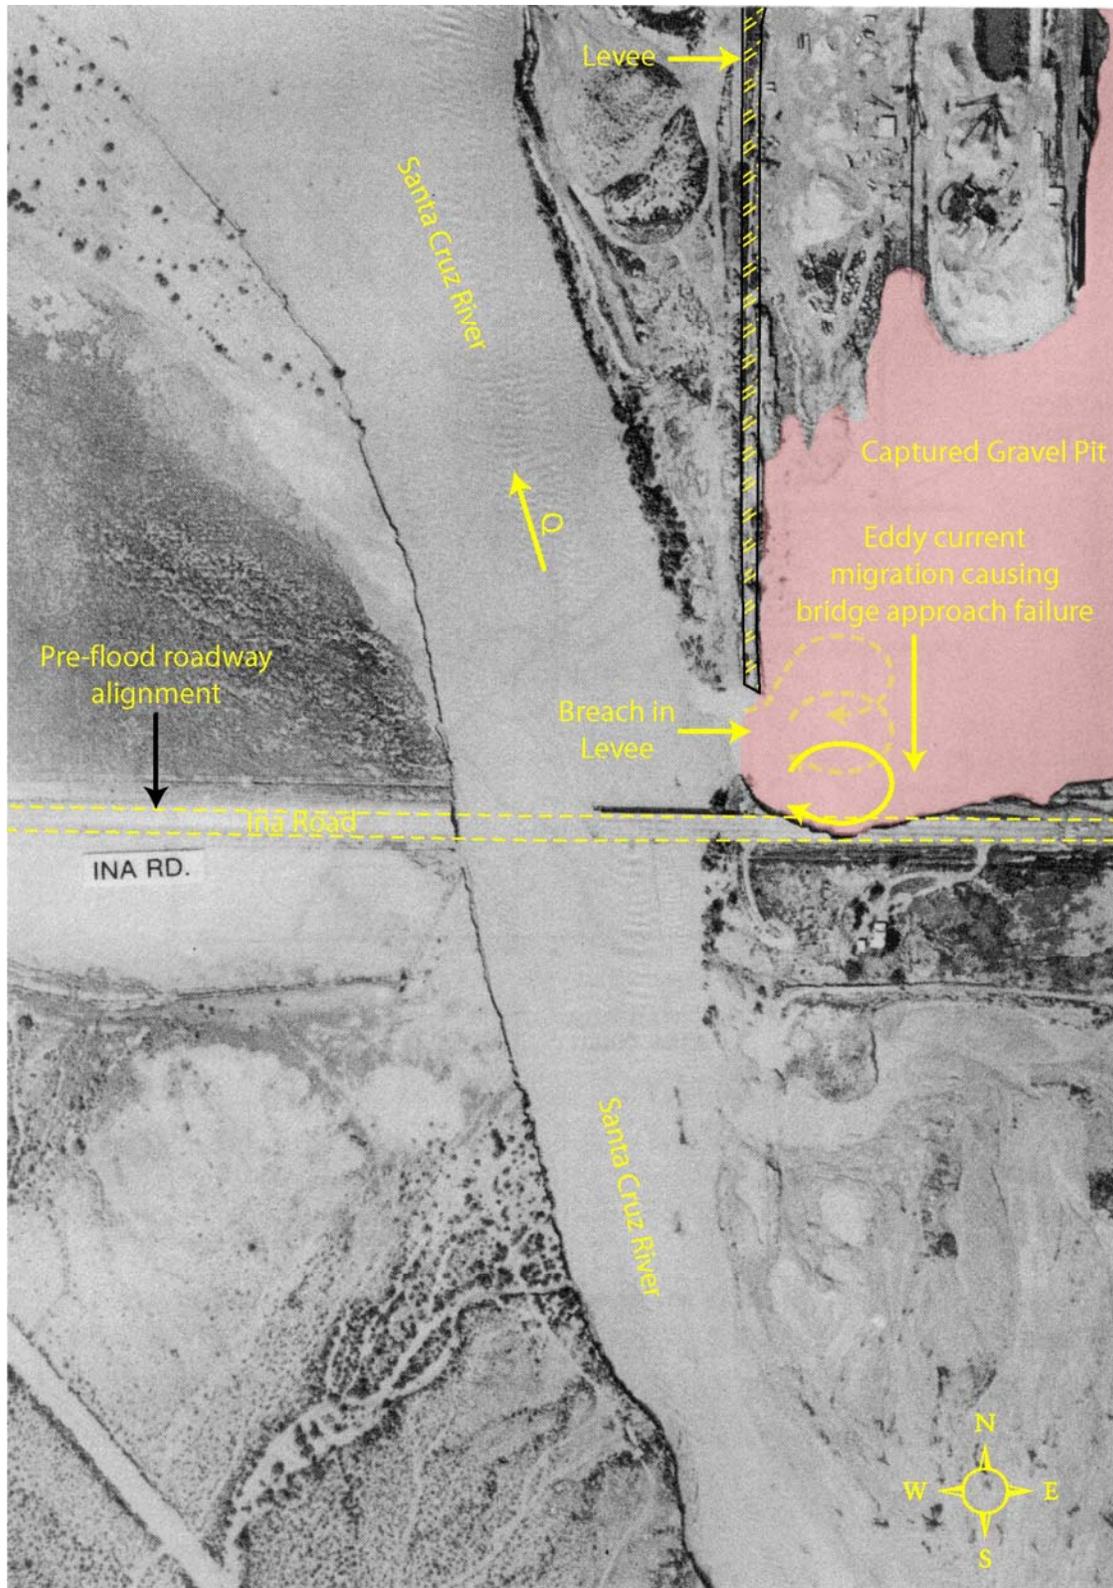
**Figure 6. Ina Rd Bridge during the October, 1983 flood. Note the erosion of Ina Road east of the bridge and main channel due to circulatory currents and local inflow to the pit (PCDOT, 1984).**
