# **Sand and Gravel Mining**

## **Floodplain Use Permit Guidelines**

**PINAL COUNTY  
May 2006**

**JE FULLER**  
HYDROLOGY & GEOMORPHOLOGY, INC.

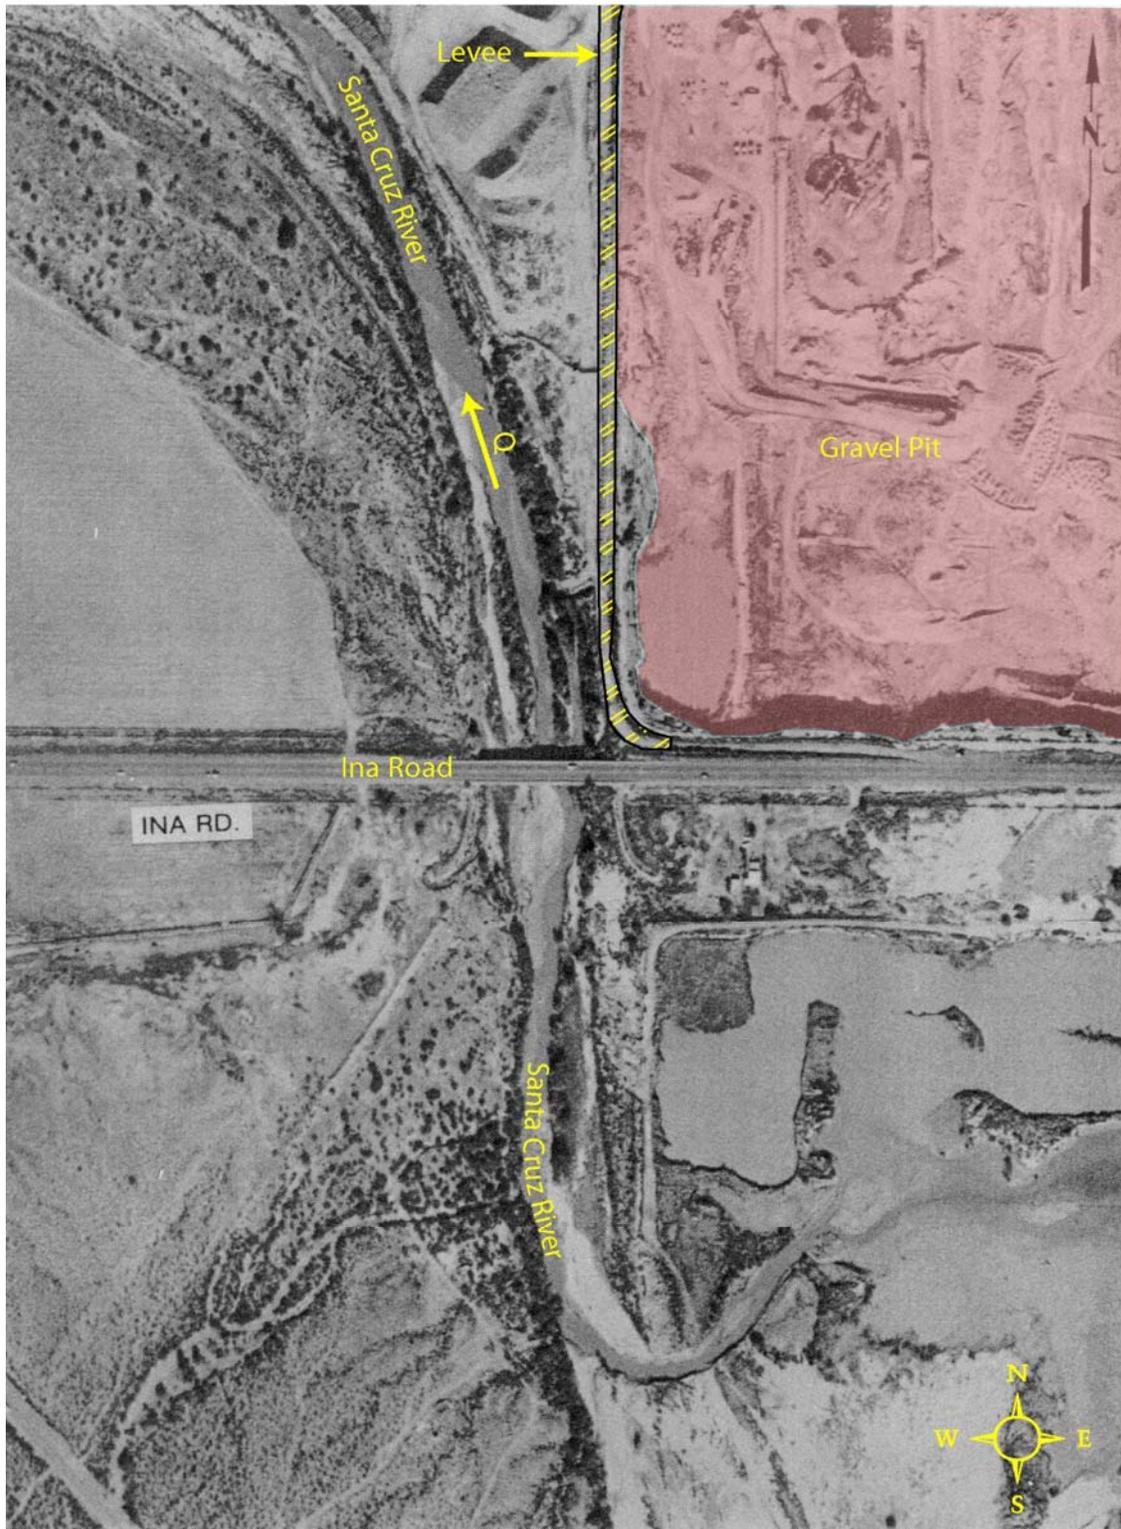
*Figure 7. Ina Road Bridge site in December, 1982 (from PCDOT, 1984). Note the steep side walls and narrow setback from Ina Road at the Columbia Pit, as well as headcut into the inundated pit south of Ina Road.*

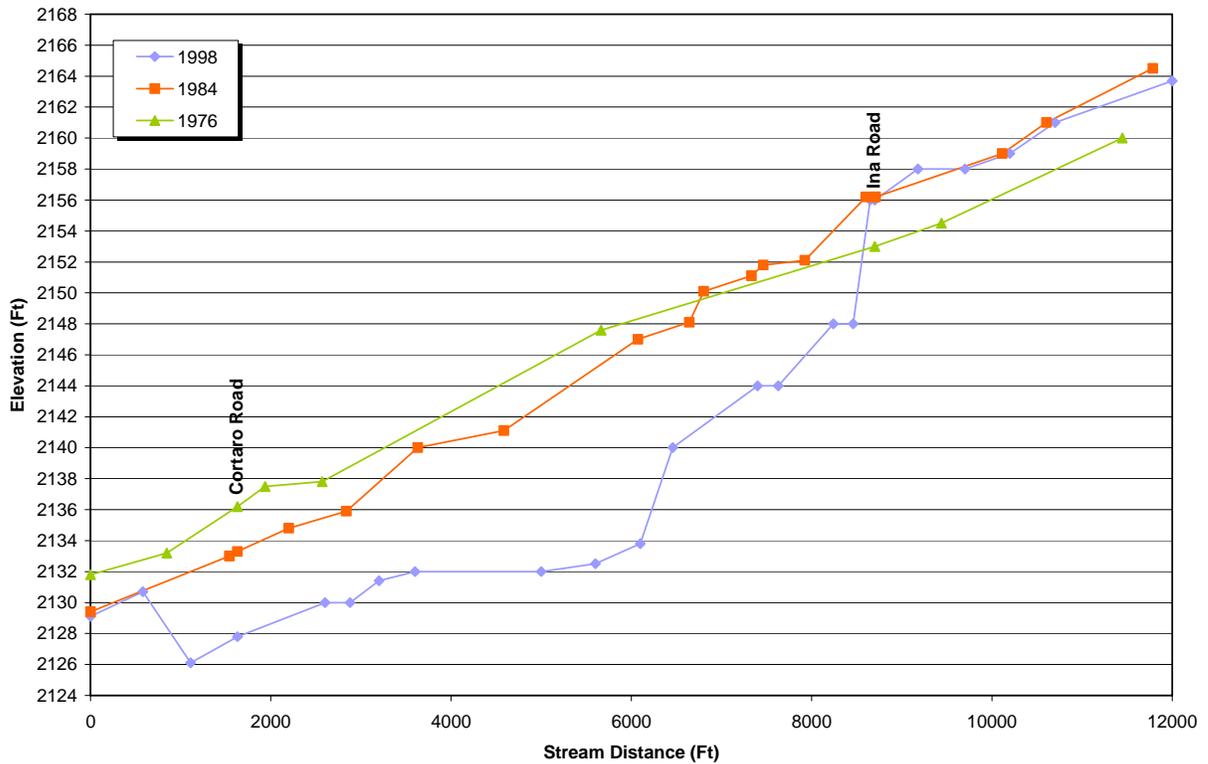
**Figure 9. Changes in channel minimum bed elevations in the Santa Cruz River from 1976 to 1998.**

Historical channel degradation also has been attributed to extensive in-stream sand and gravel mining of the Santa Cruz River during the 1950's and 1960's (SLA, 1986). In ephemeral streams like the Santa Cruz River, much of the long-term degradation occurs during large floods like the 1983 event particularly when the main channel captures deep excavations in the floodplain. Channel elevation profiles of the Santa Cruz River shown in Figure 9 document the degree of long-term degradation that occurred near Ina Road. While pre- and post-flood topographic data are not available to determine how much headcutting occurred at Ina Road, the data in Figure 9 indicate the potential for future degradation at Ina Road caused by downstream excavations.

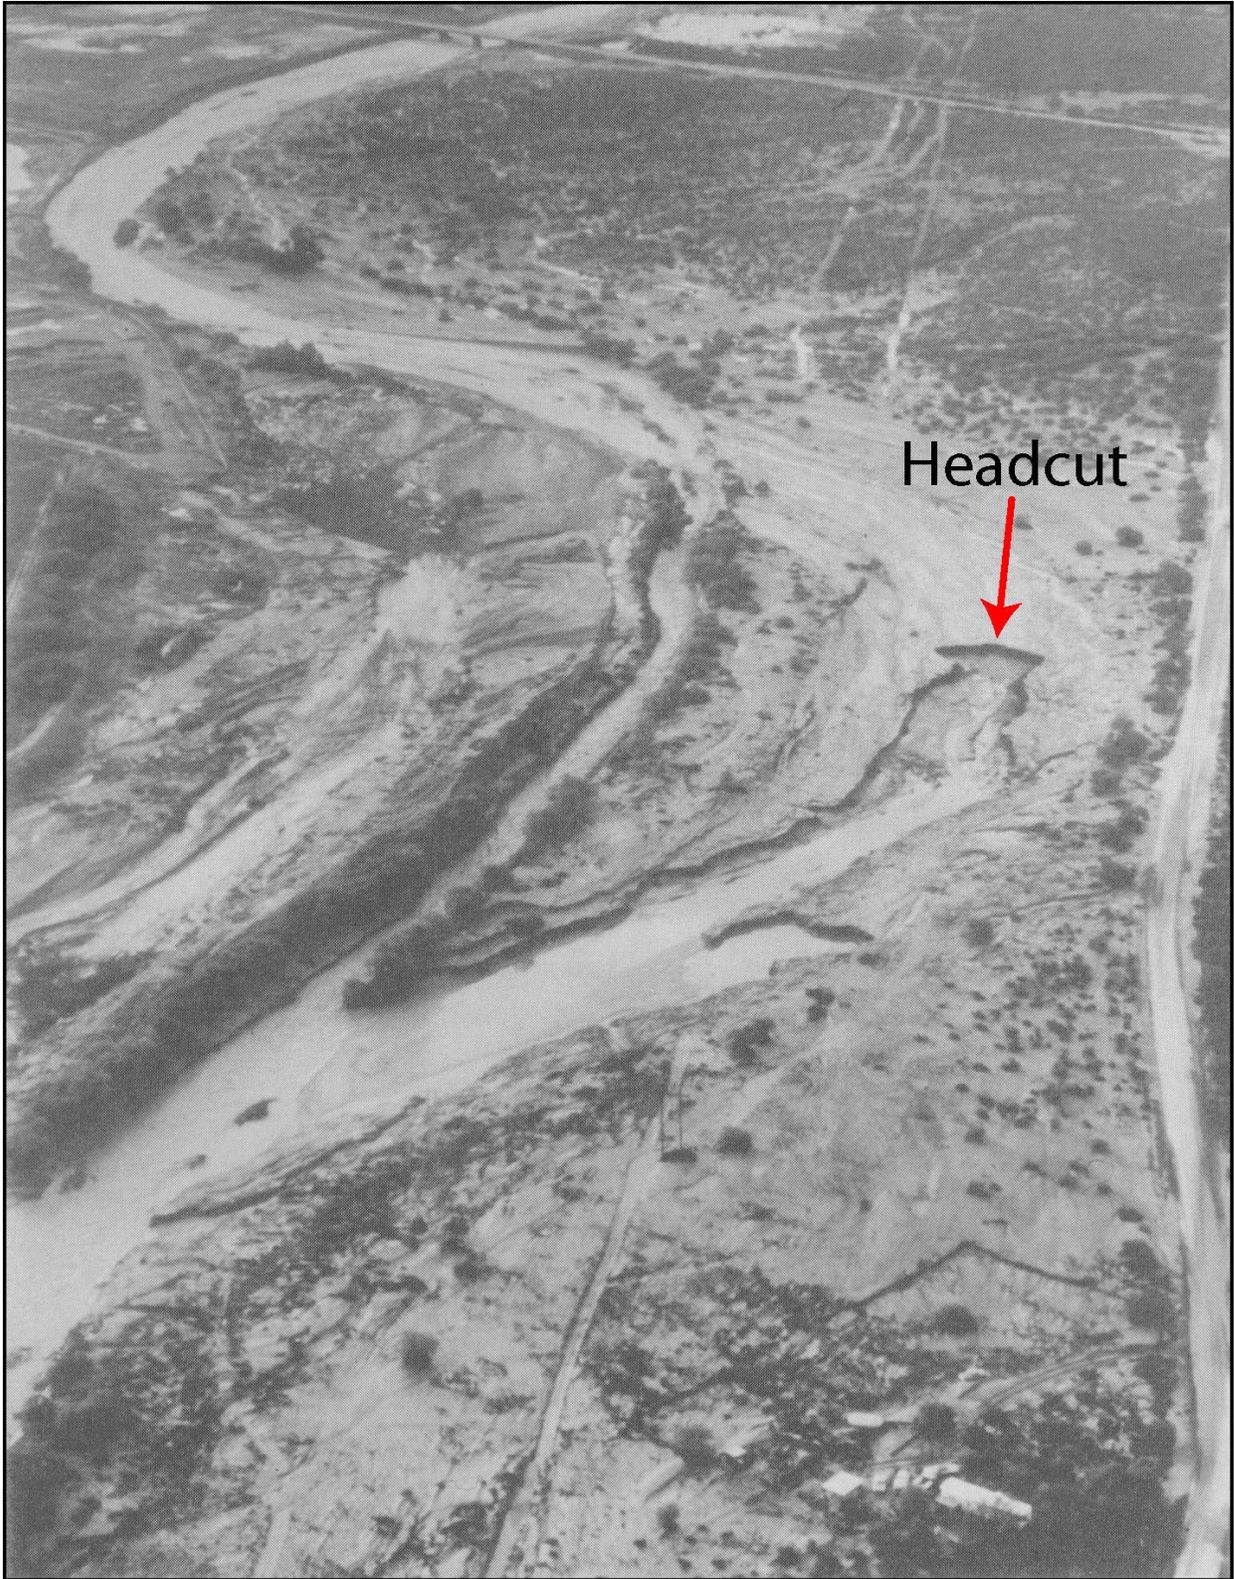
*Figure 10. Headcut on the Santa Cruz River floodplain, October 1983 (Baker et al., 1988).*

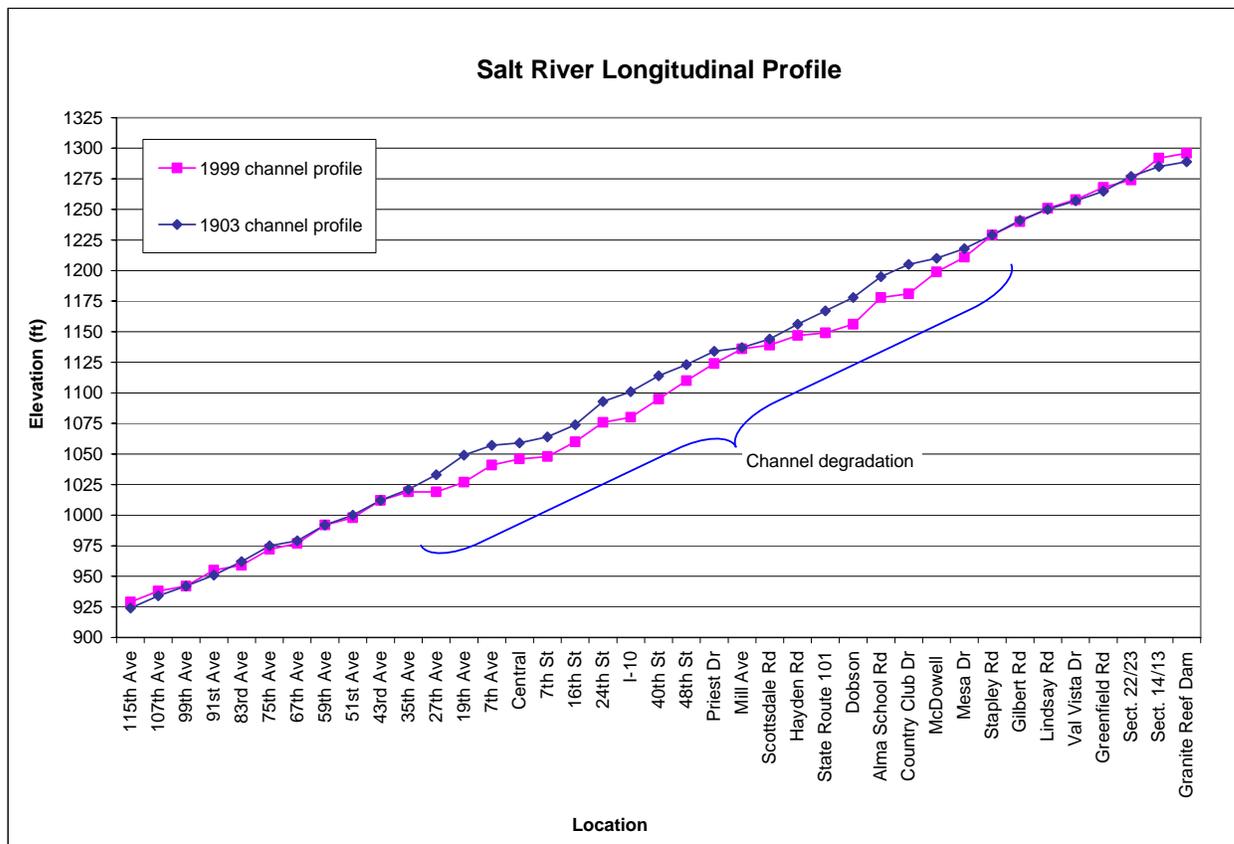
Figure 9. Longitudinal profiles of the Salt River in 1903 and 1999.

The longitudinal profiles shown in Figure 9 reveal that the most significant channel degradation occurred between 35<sup>th</sup> Avenue and Stapley Road, and that the reaches upstream and downstream experienced little long-term degradation. The lack of measurable long-term degradation at the upstream and downstream ends of the study

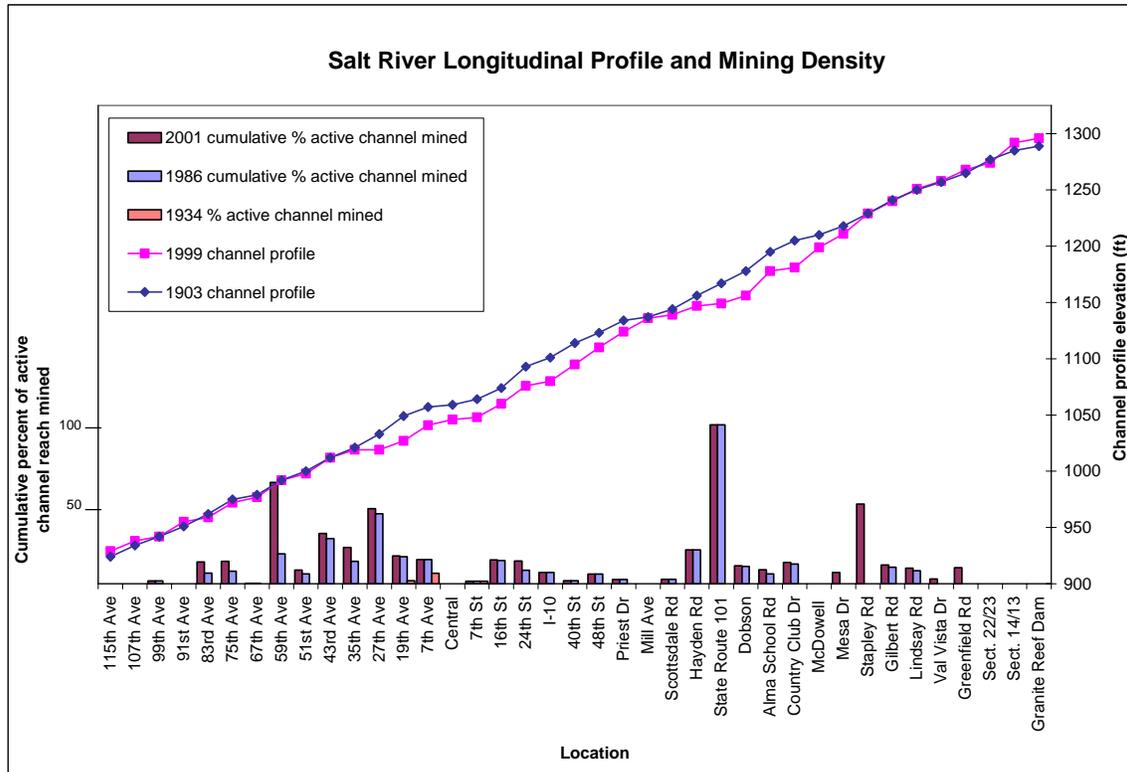
Figure 7. Mining density in 1934, 1986, and 2001 relative to long-term degradation.

As shown in Figure 7, the most intense in-stream mining of the study reach occurred in two primary mining clusters. One cluster extends from about 59<sup>th</sup> Avenue to 7<sup>th</sup> Avenue. The other cluster extends from about Hayden Road to Country Club Drive. Both mine clusters are located near the downstream ends of the most highly degraded reaches, at the 35<sup>th</sup> Avenue alignment and at Scottsdale Road.<sup>4</sup> The position of the mining clusters relative to the degraded reaches suggest that degradation of the channel upstream of the apex points may be caused by long-term headward erosion from the mining activity in addition to removal of material through excavation. However, it is no coincidence that the most heavily channelized and narrowed reach of the Salt River corresponds to the highly degraded reach located upstream of 59<sup>th</sup> Avenue and downstream of Gilbert Road.

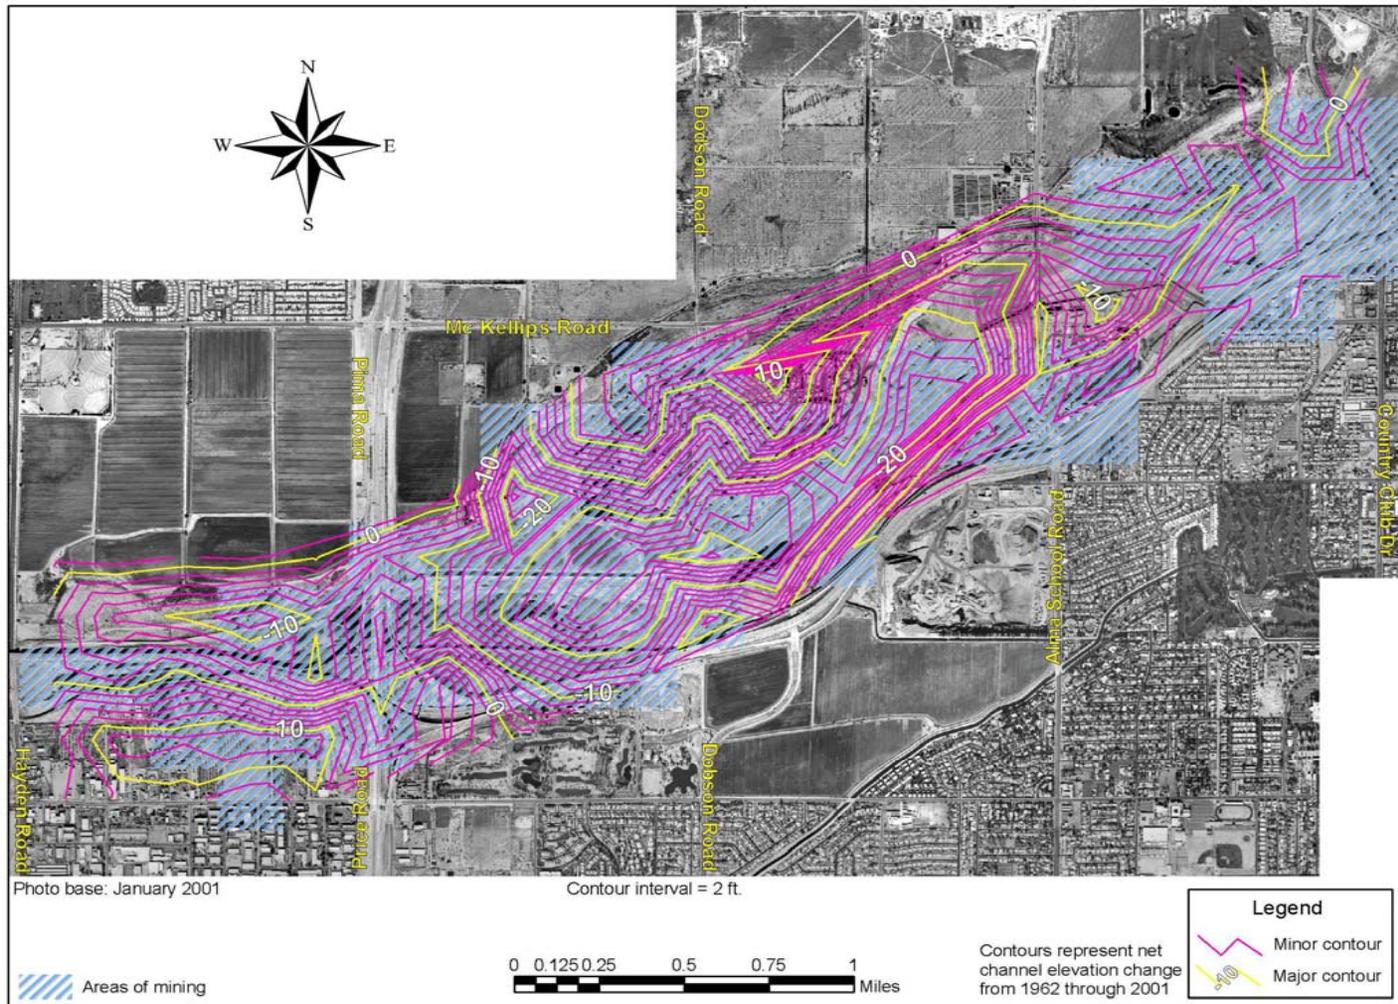
Figure 13. Topographic map of long-term channel elevation change (1962-2001) in the Hayden-Country Club Mining Cluster.

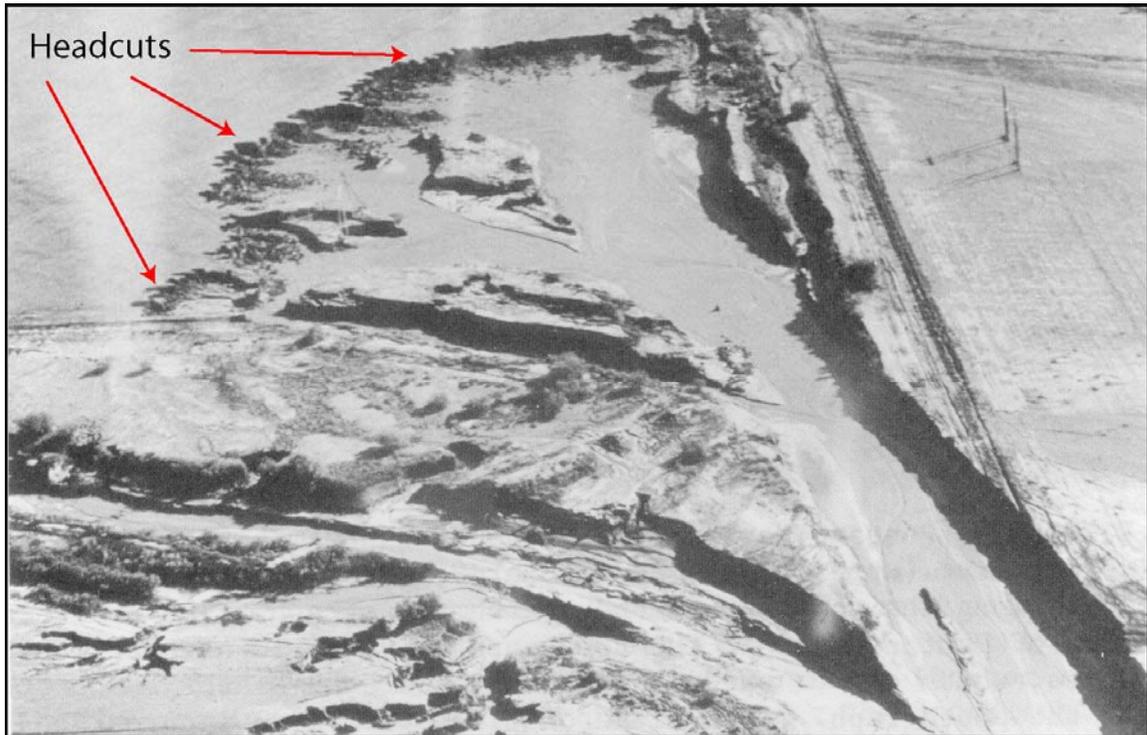
*Figure 15. Headcutting on the Santa Cruz River 9 miles northwest of Marana, AZ, October 1983 (Saarinen et al., 1984) .*

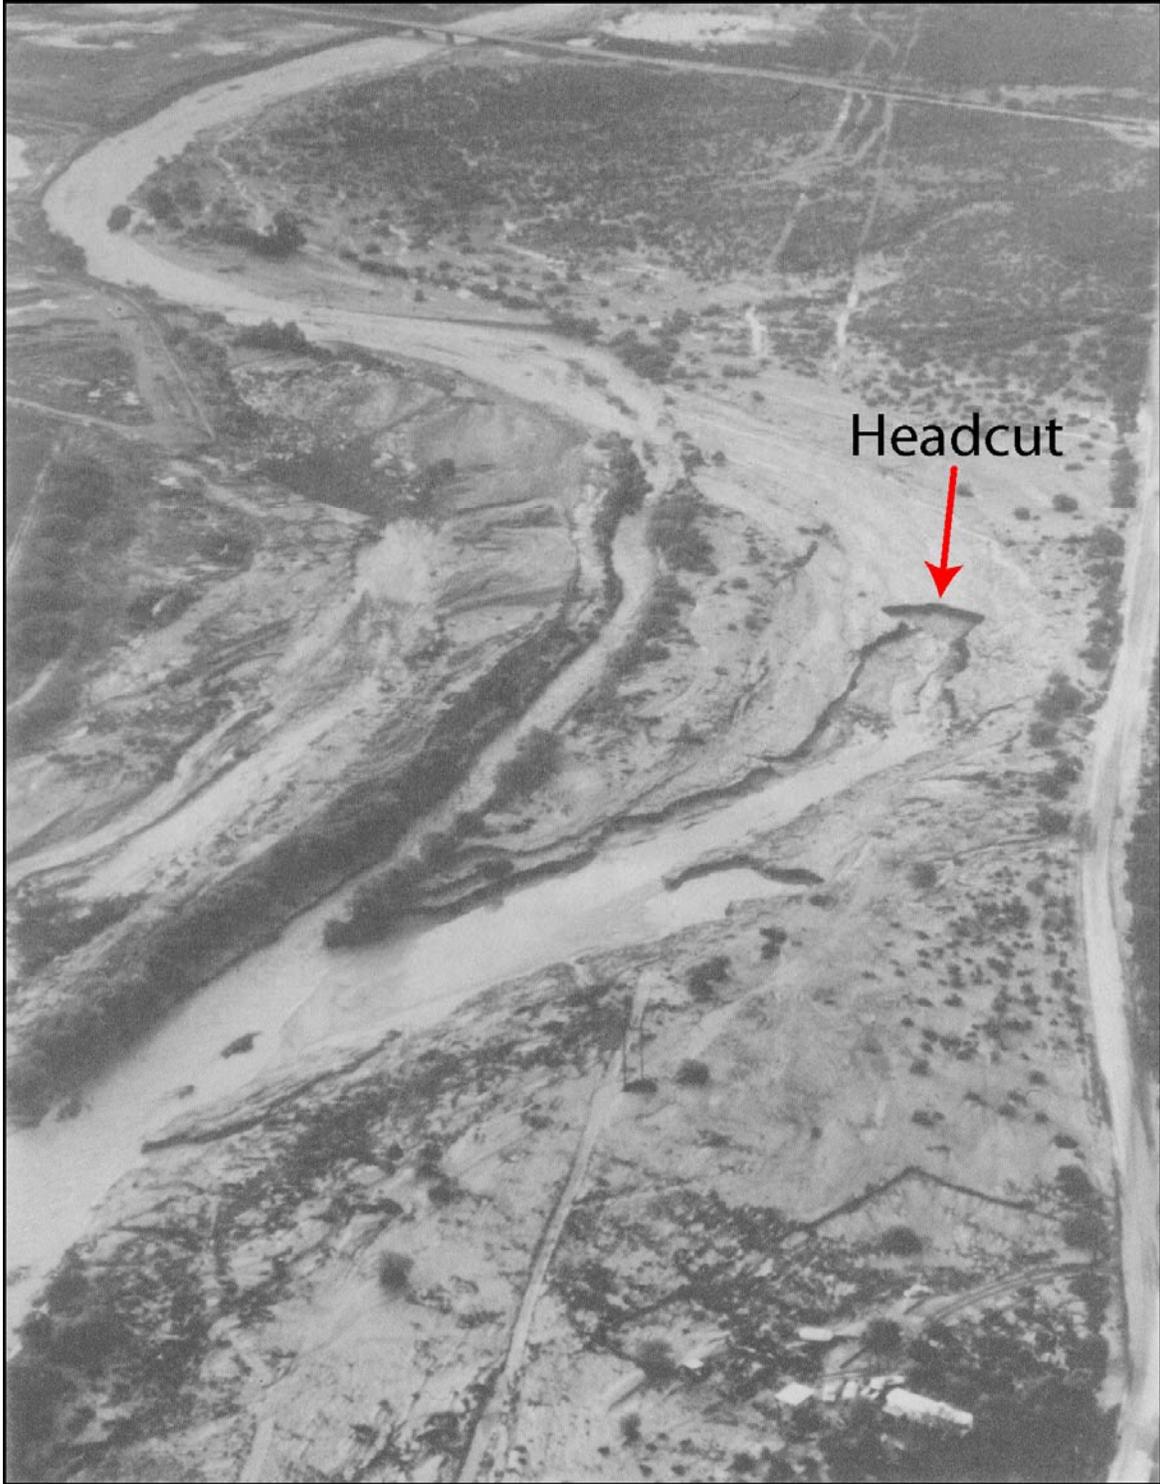
*Figure 17. Headcuts on the Santa Cruz River floodplain, October 1983 (Baker et al., 1988).*
